MARINE ACCIDENT INVESTIGATION BRANCH

SAFETY FLYER TO THE FISHING INDUSTRY

Fishing vessel *Majestic* flooding and foundering off Shetland, 21 January 2016

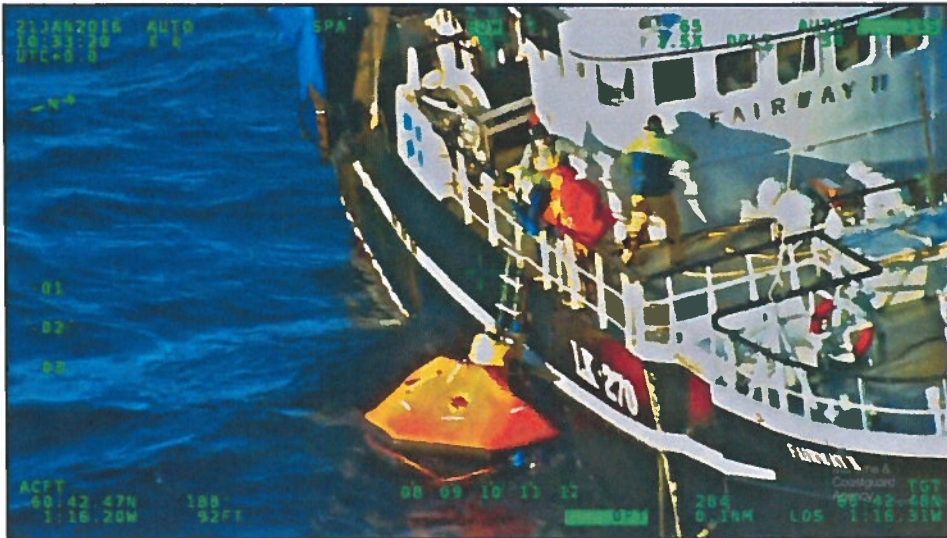
Photograph of crew boarding *Fairview II*
