MARINE ACCIDENT INVESTIGATION BRANCH

SAFETY FLYER TO THE FISHING INDUSTRY

Fishing vessel *Majestic* flooding and foundering off Shetland, 21 January 2016

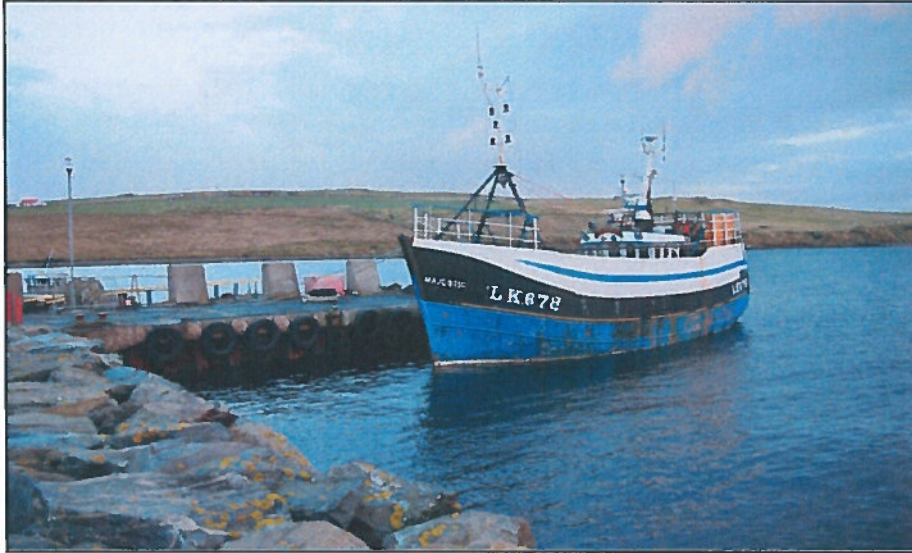
At 1443 on 21 January 2016 the 16m wooden potter *Majestic* (LK678) sank close to a gas pipeline off the Point of Fethaland, Shetland. Around 4¾ hours earlier, the vessel's skipper returned to the wheelhouse after he had finished working a fleet of creels on deck with his crewman. When he arrived in the wheelhouse, the engine room bilge alarms were sounding. The skipper alerted the crewman, who lifted the engine room escape hatch and saw that water was half way up the side of the engine casing.

Majestic remained upright and on an even keel. Over the next 4 hours, the vessel drifted to the north until it foundered at 1443, at the time the vessel's EPIRB released and activated. *Majestic* came to rest on the sea bed just 2 metres from the Orka Vow gas pipe line. Consequently, a remotely operated vehicle was later used to put sandbags between the wreck and the pipeline to prevent damage to the pipeline.

The cause of the engine room flood is unknown, but it was probably connected with a failure within a seawater system. The investigation identified that:
